DRAFT AFTER ACTION REPORT

**Hi-Tech Plating Facility
Balch Springs, Dallas County, Texas**

**EPA - REGION VI
EMERGENCY RESPONSE BRANCH**

**Ecology and Environment, Inc.
Technical Assistance Team**

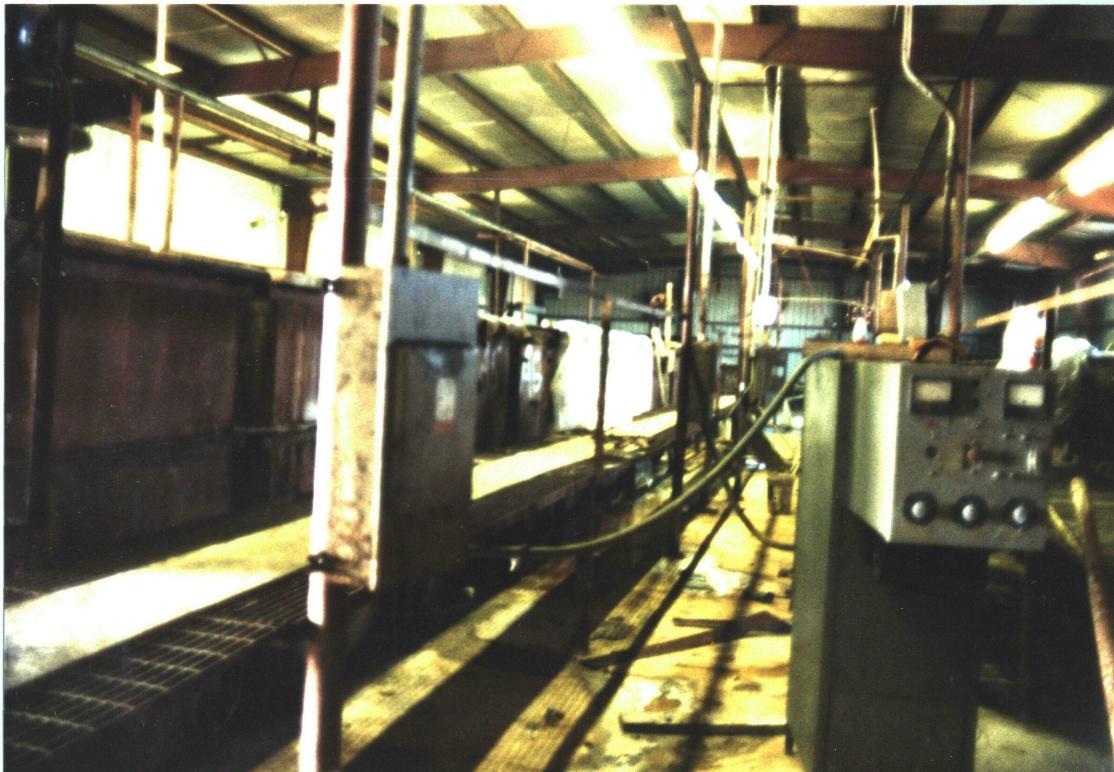
Comments: Pan shot of berm erected by ERCS
to control any potential leaks from vats.

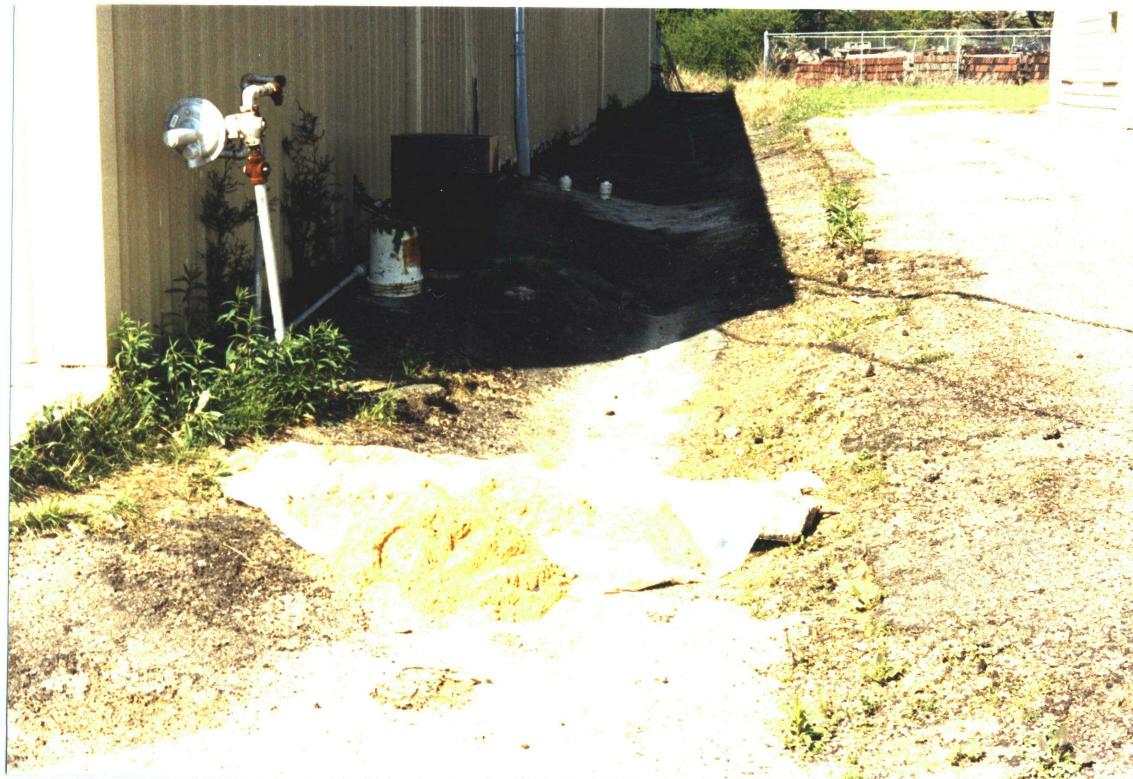
Comments: Berm erected by ERCS to contain spill from leaking vats on south end of building.

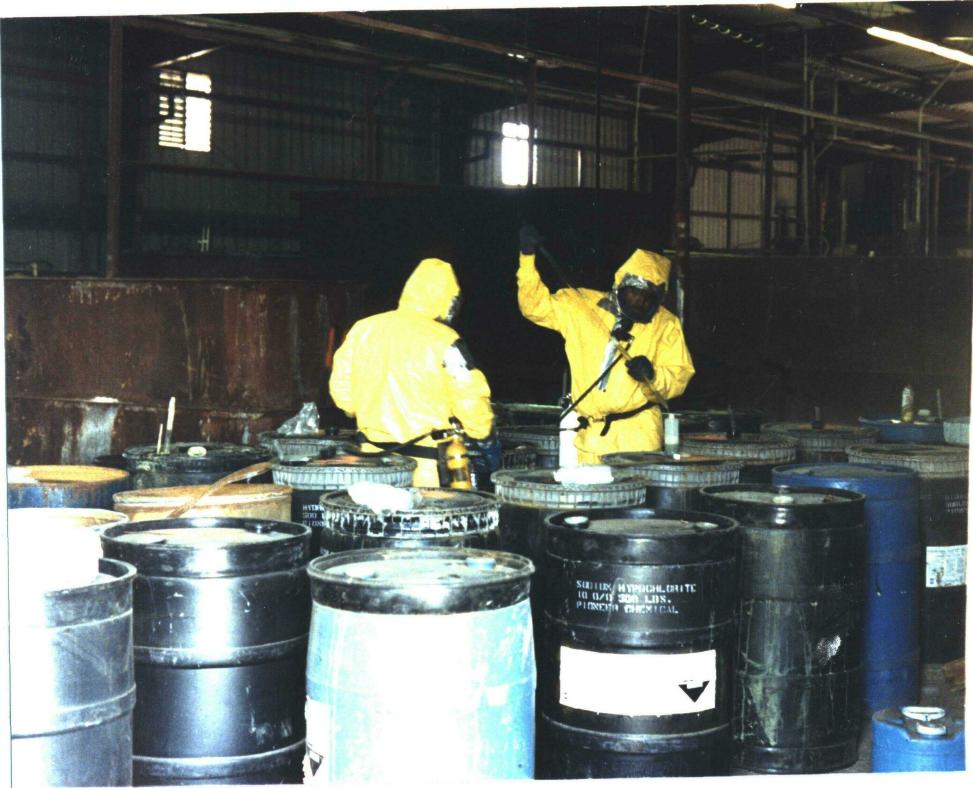
Comments: ERCS collecting drum sample with drum theive for disposal profile.

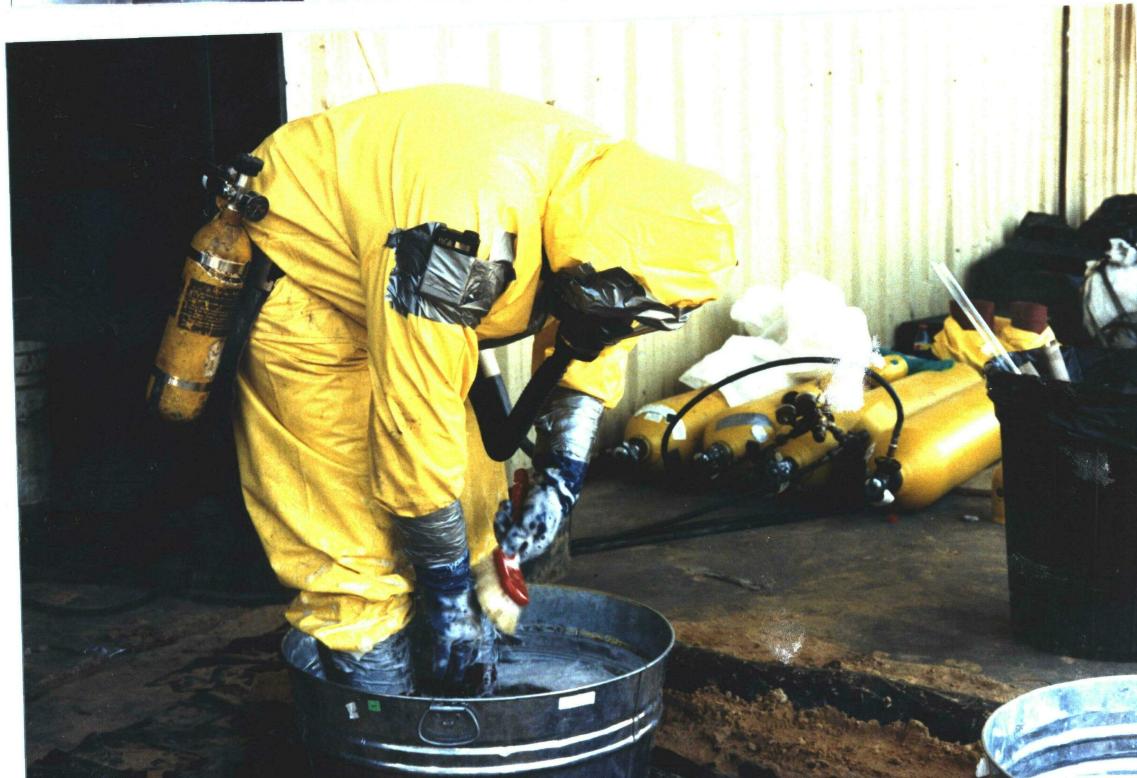
Comments: ERCS personnel deconning from exclusion zone after sampling vats & drums.

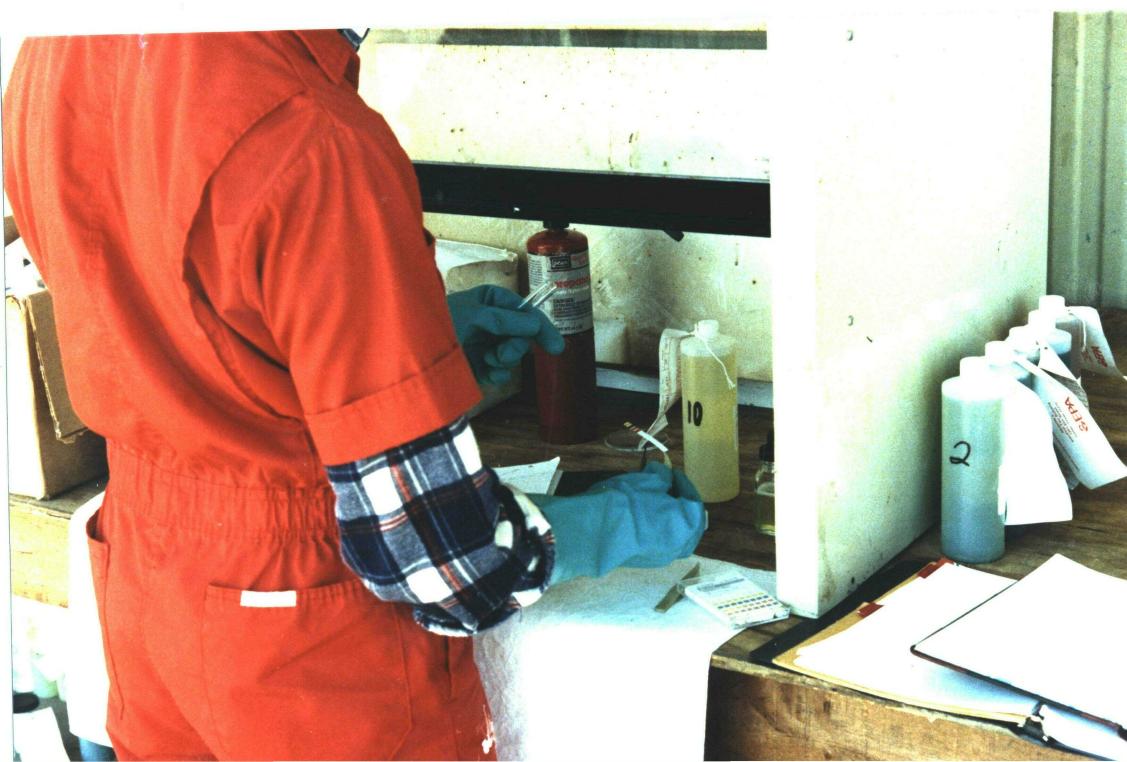
Comments: ERCS chemist taking pH measure-
ment of vat sample.

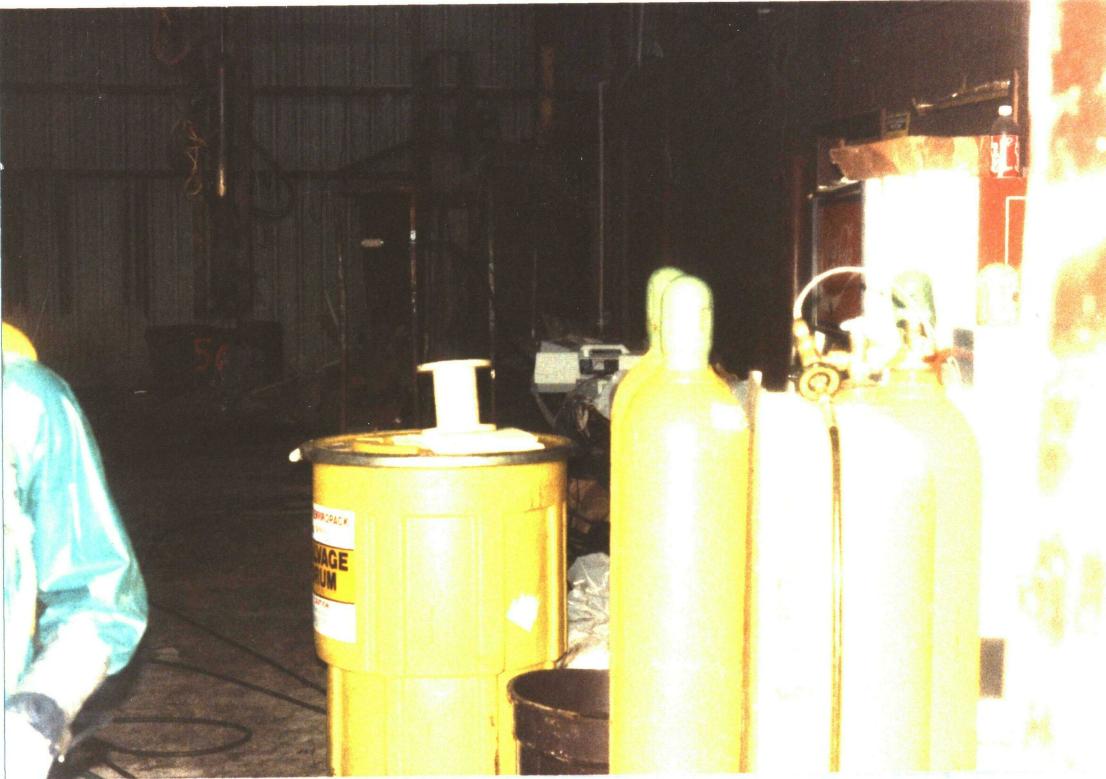
Comments: Air bottles used for Level B
work in exclusion zone.

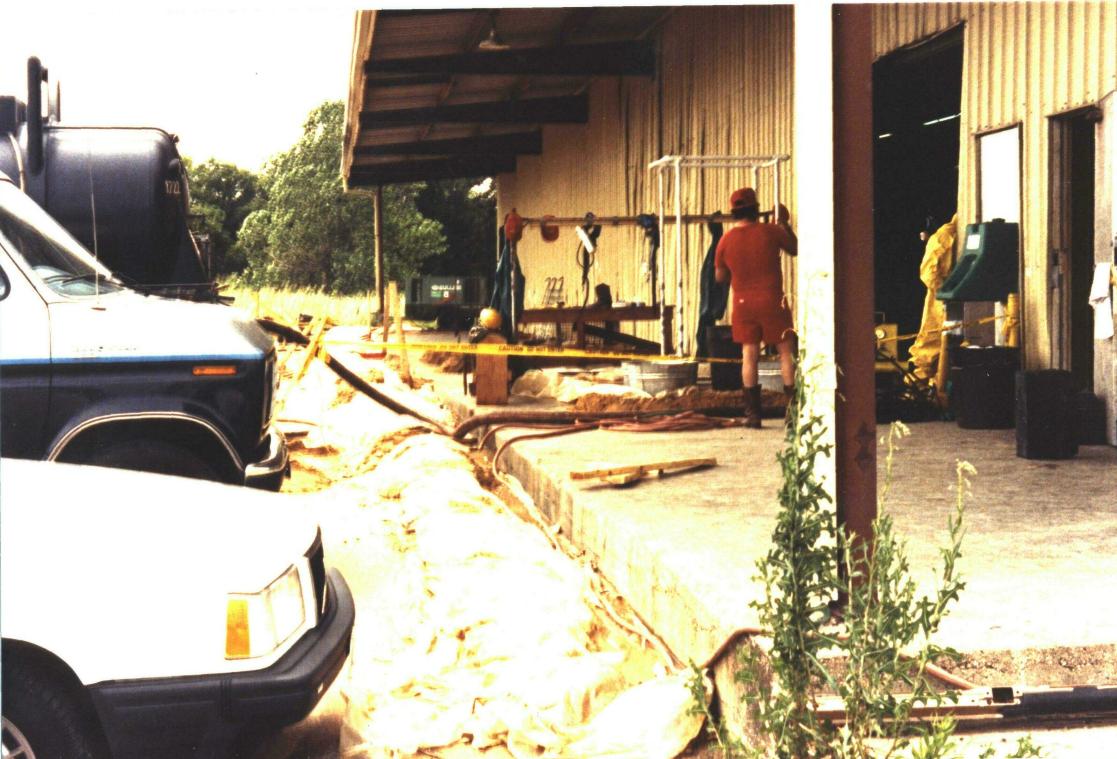
Comments: Decon station erected by ERCS
before vat removal commences.

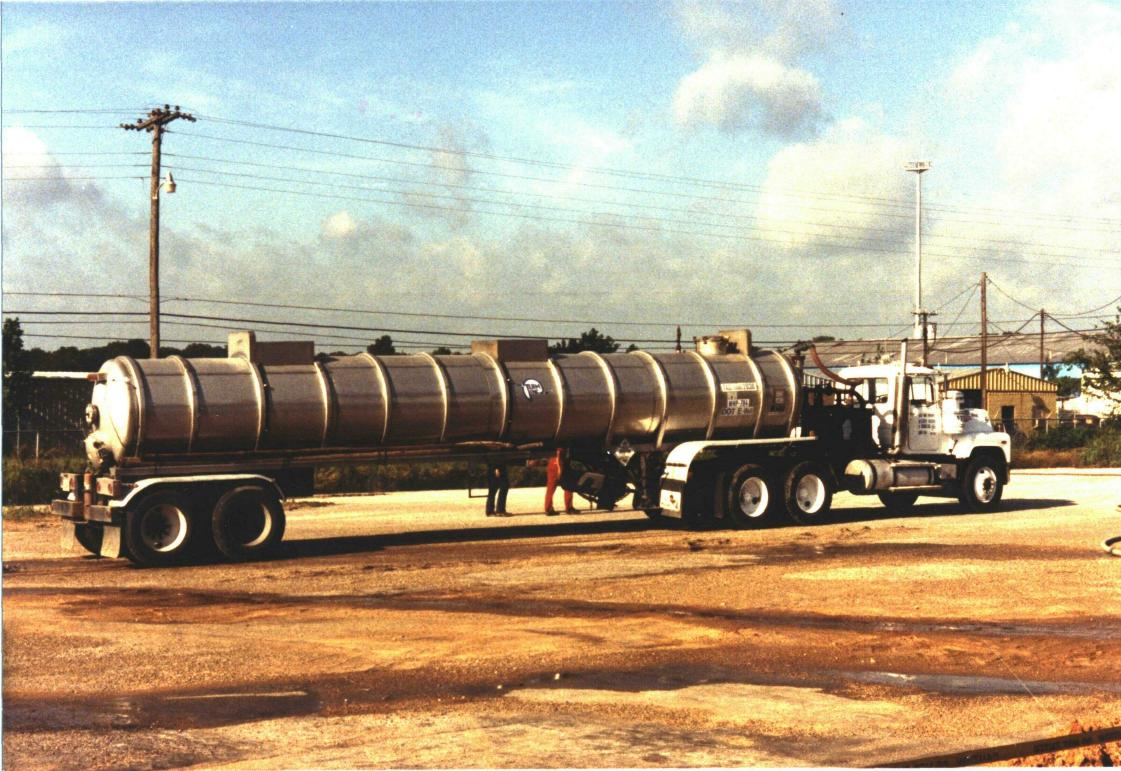
Comments: Vacuum truck onsite used to transfer site liquid wastes to disposal facility.

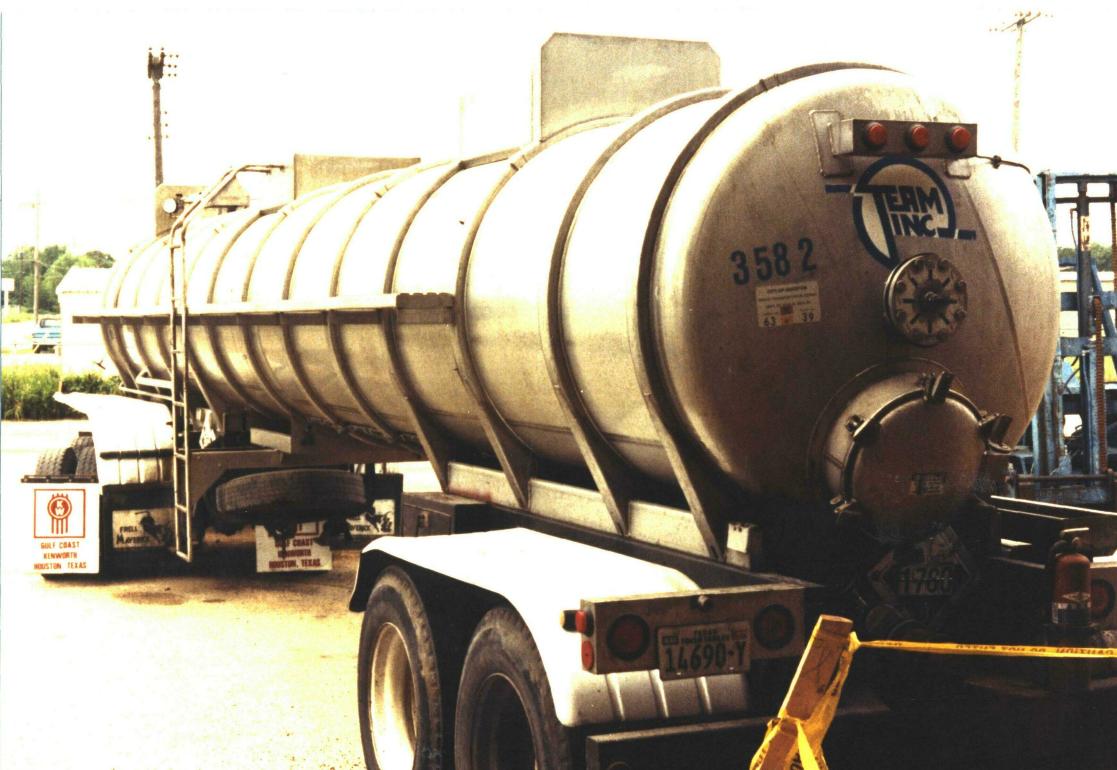
Comments: Placards on vac truck before departure to disposal facility.

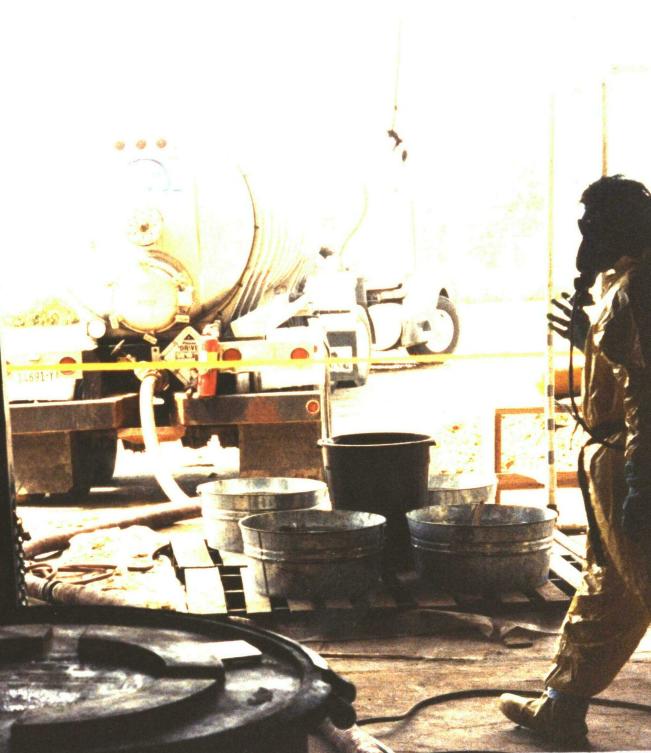
Comments: Vac truck hose used to pump vat wastes into truck for disposal.

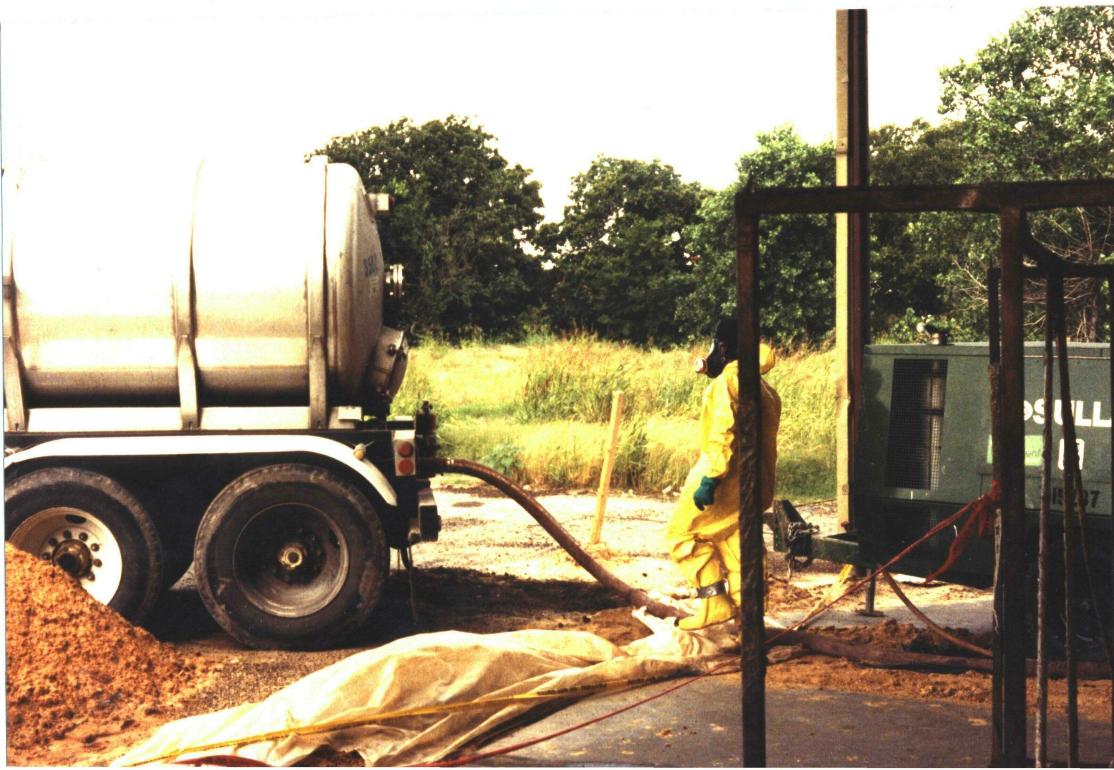
Comments: Vac truck used to pump wastes from vat for transport to disposal facility.

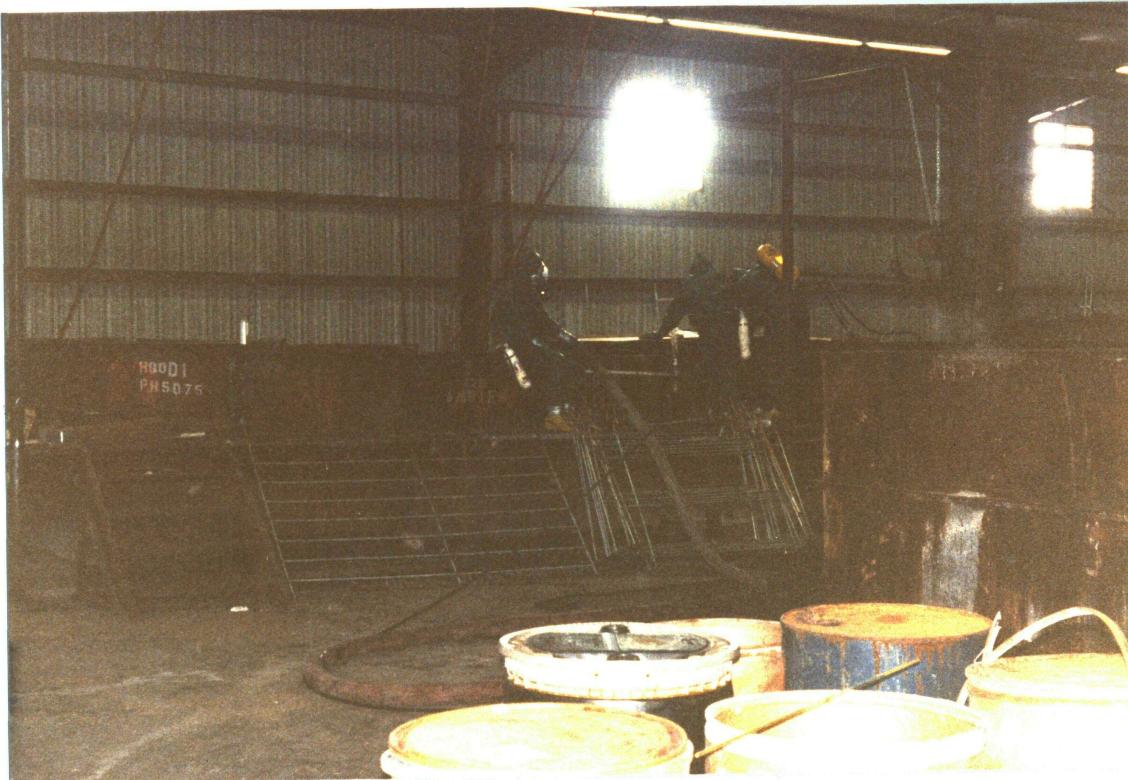
Comments: ERCS pumping vat contents into consolidation vat for preparation of transfer into vacuum truck.

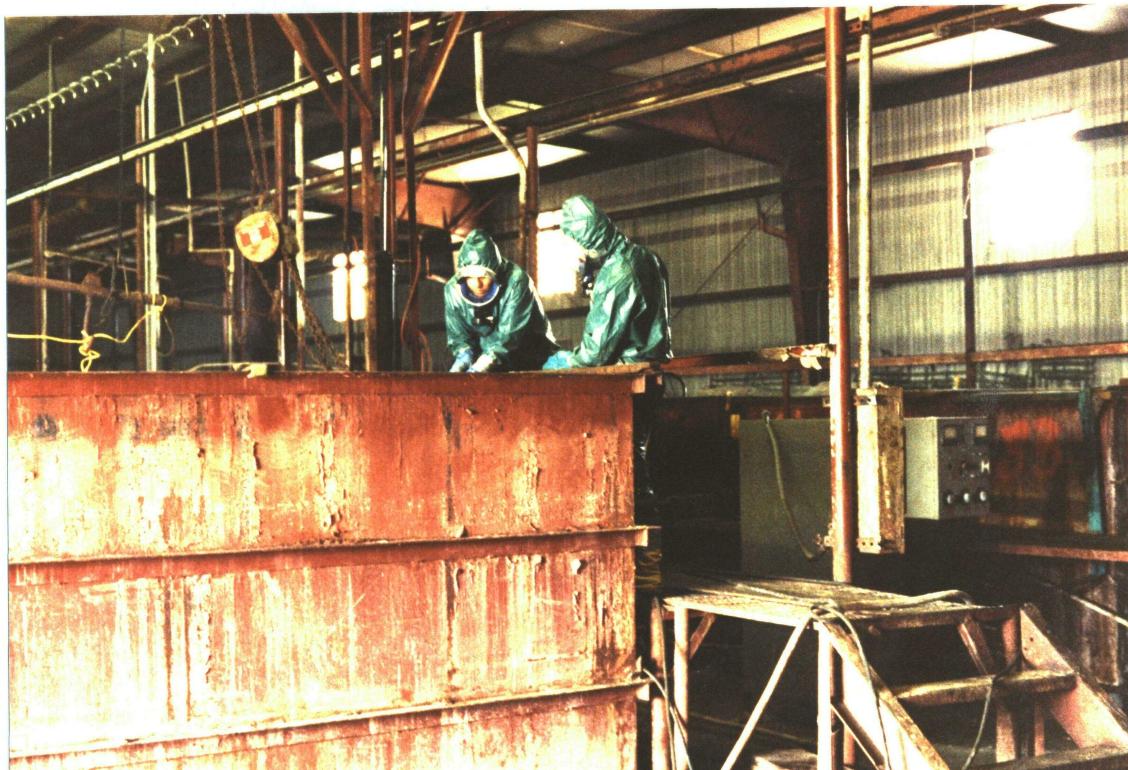
Comments: ERCS rinsing empty vat for removing vat residue and later disposal as scrap metal.

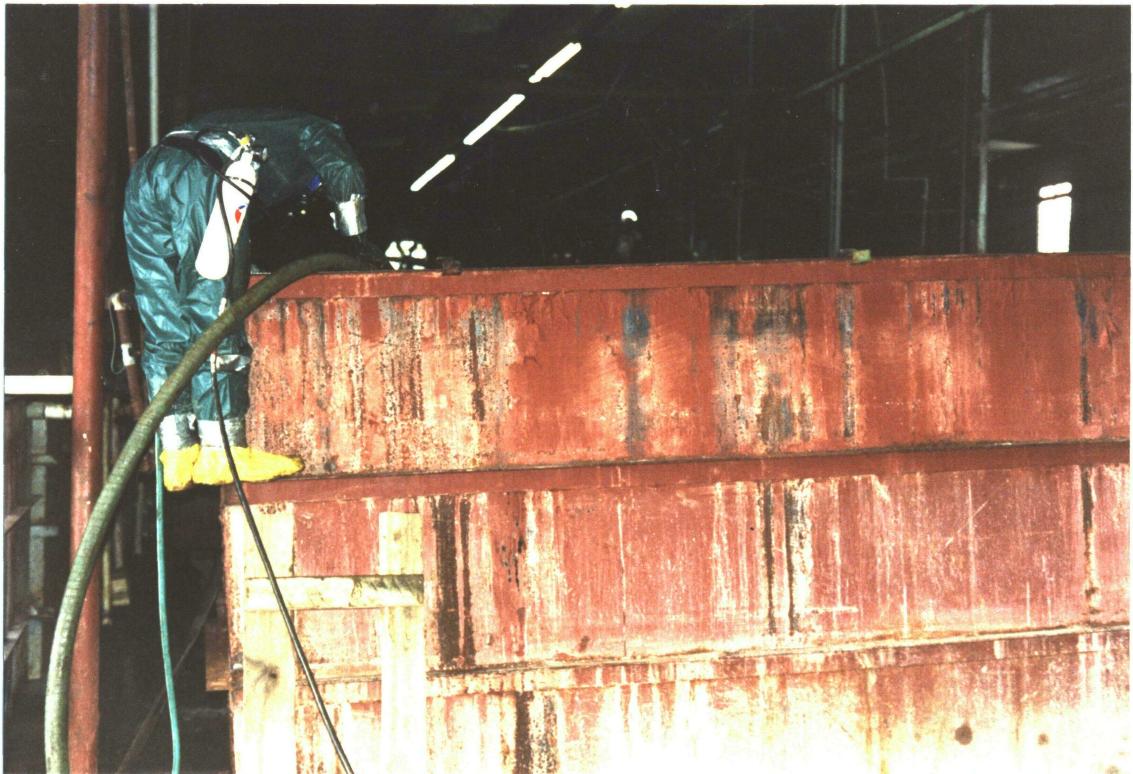
Comments: ERCS pumping cyanide sludge
to vac truck for disposal.

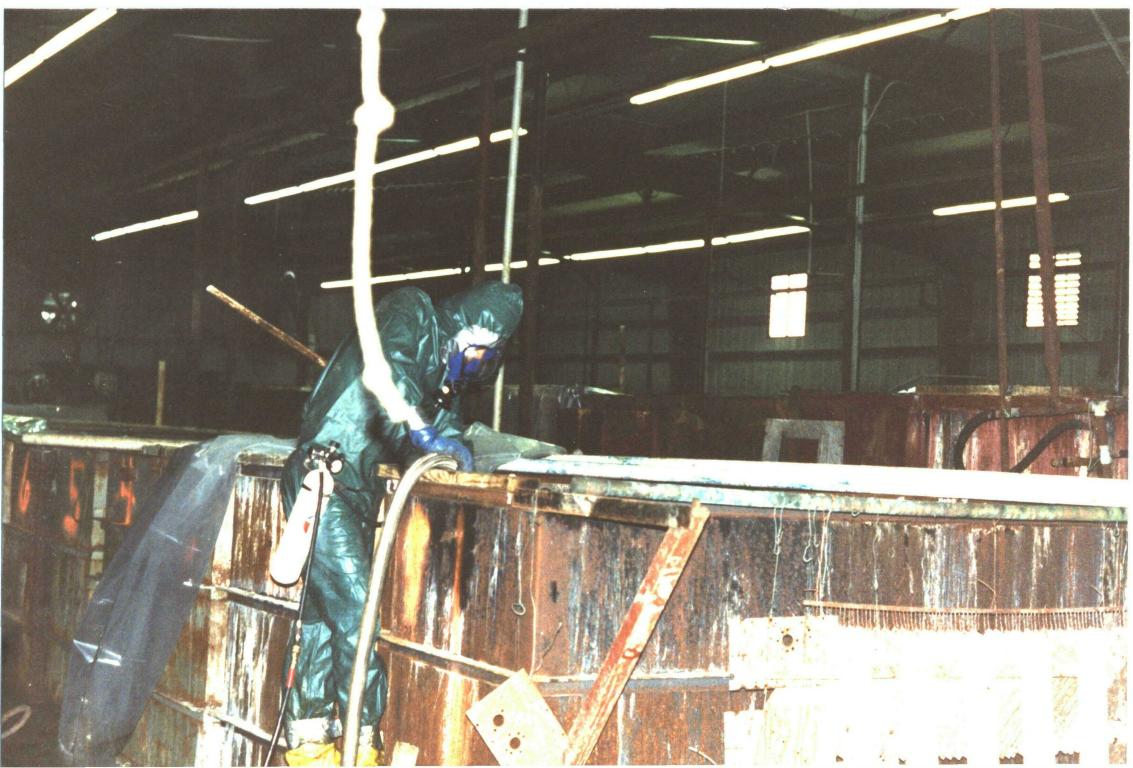
Comments: ERCS rinsing emty vat for
later disposal as scrap metal.

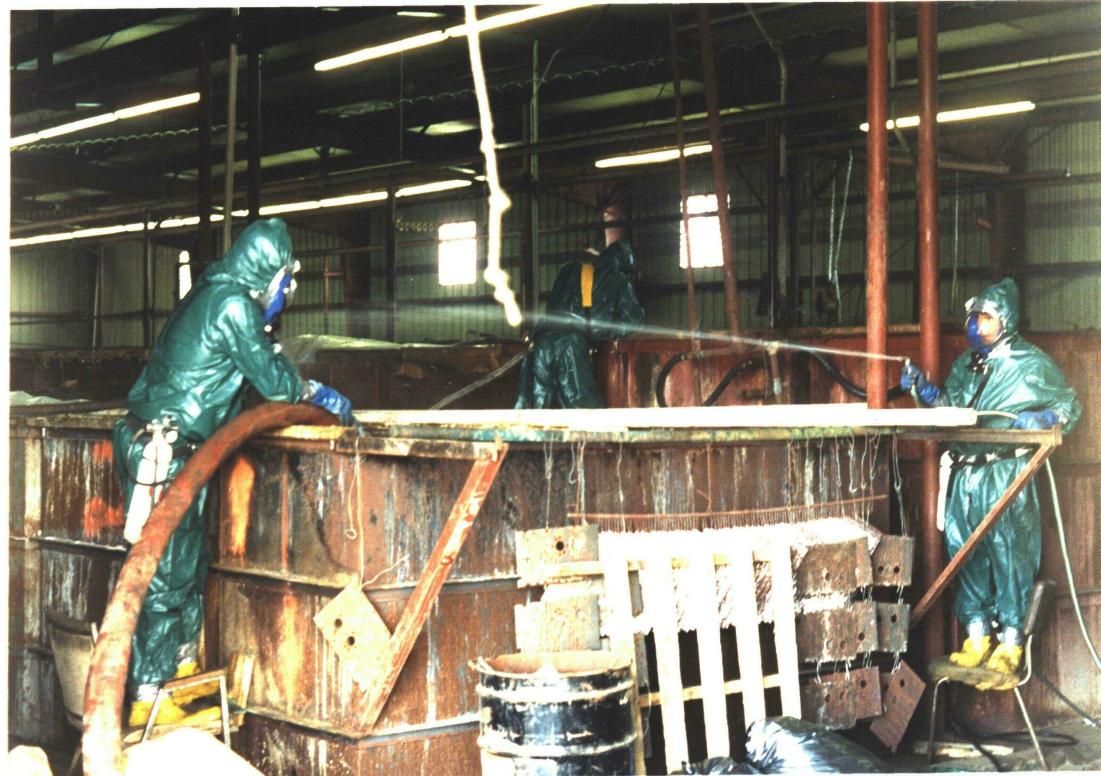
Comments: ERCS crew pumping vat to vac truck and rinsing residue.

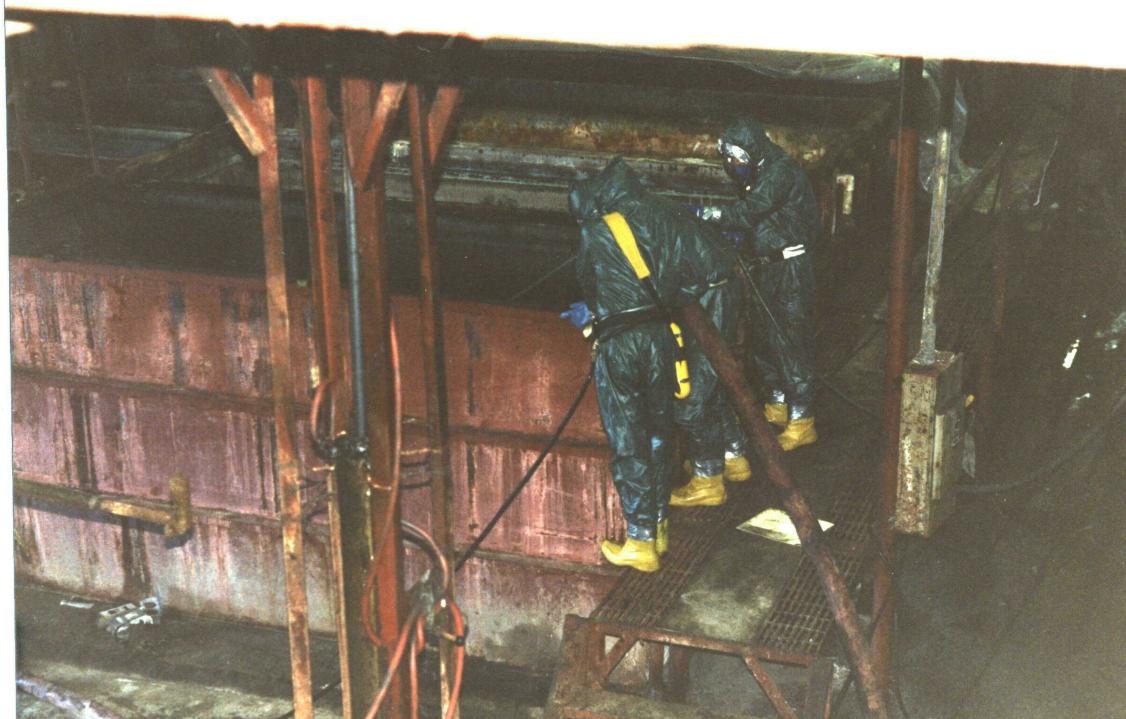
Comments: Crew pumping liquids to vac truck and rinsing after pump completion.

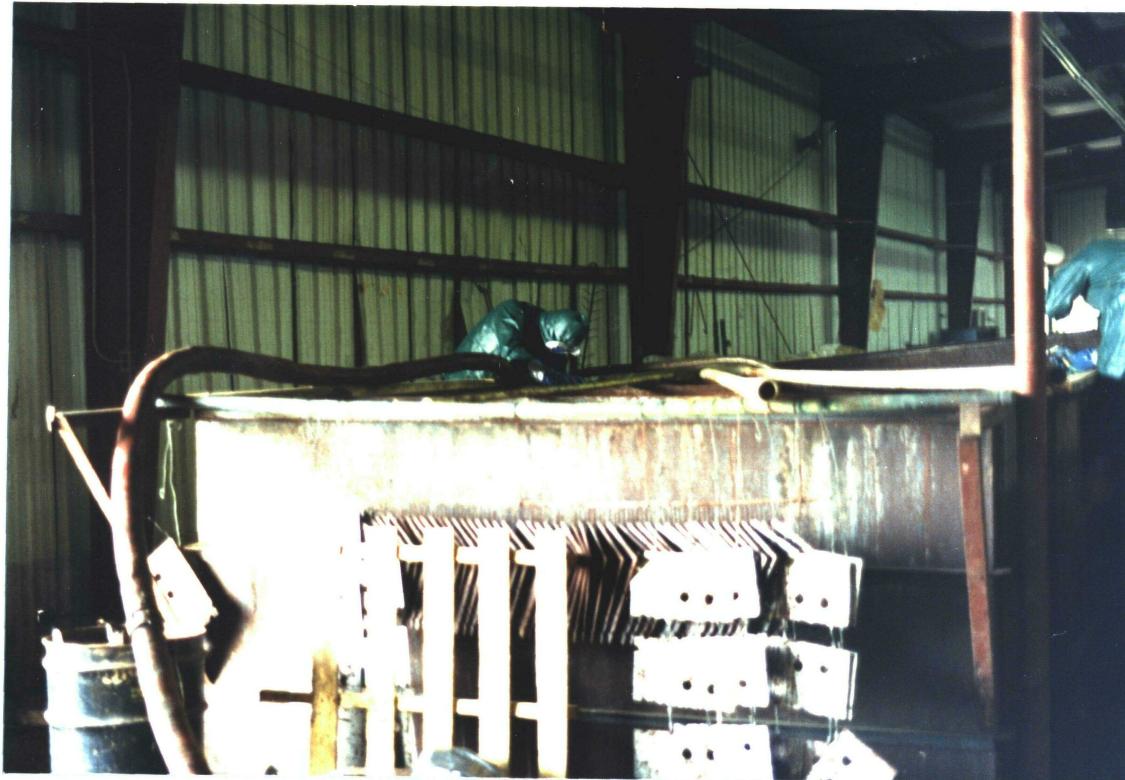
Comments: Crew pumping vat liquids into consolidation vat for easing pumping of liquids into vac truck.

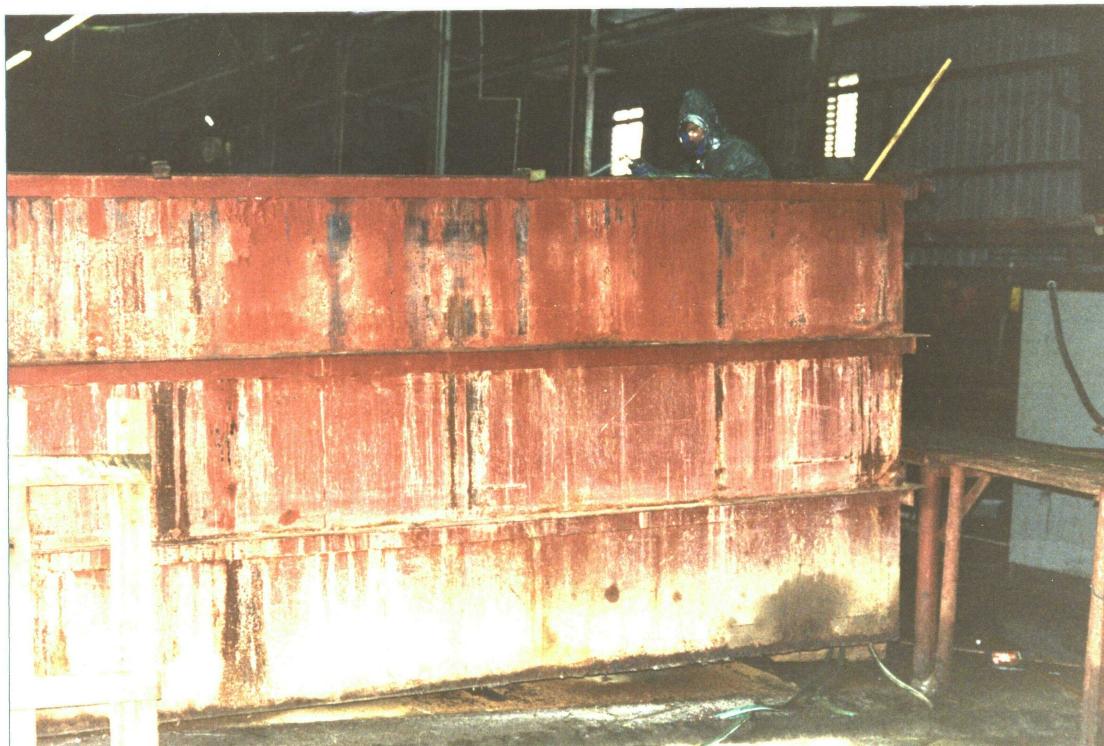
Comments: ERCS rinsing vats for later scarp metal disposal.

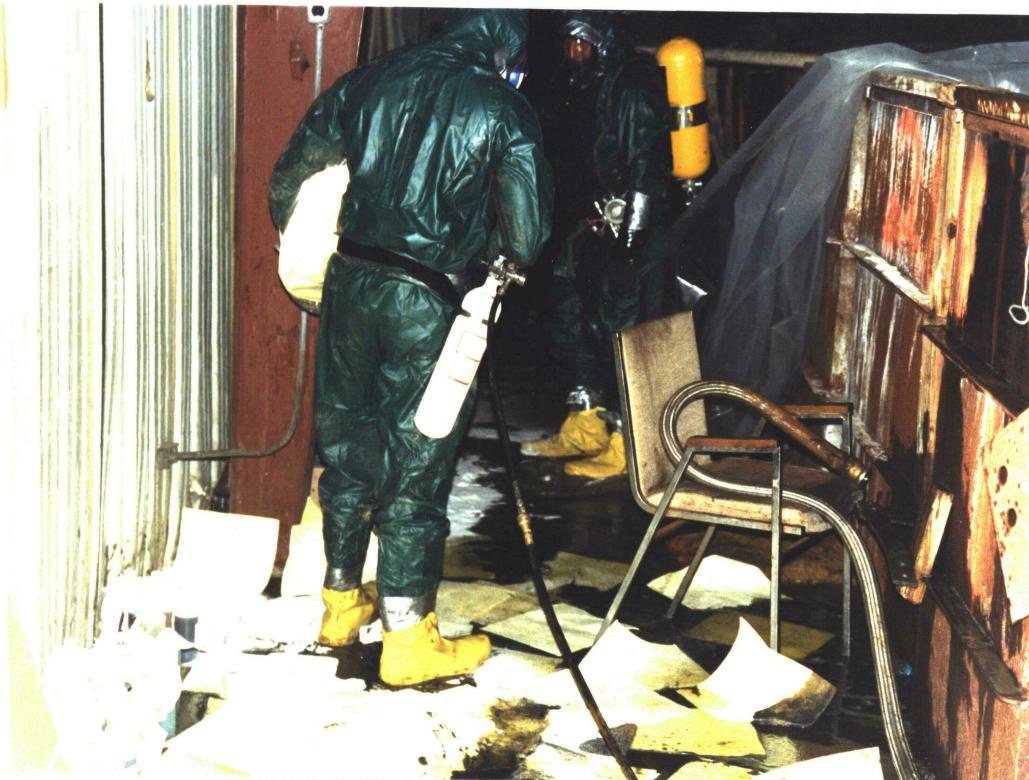
Comments: Crew using absorbent material
to contain leak from vat.

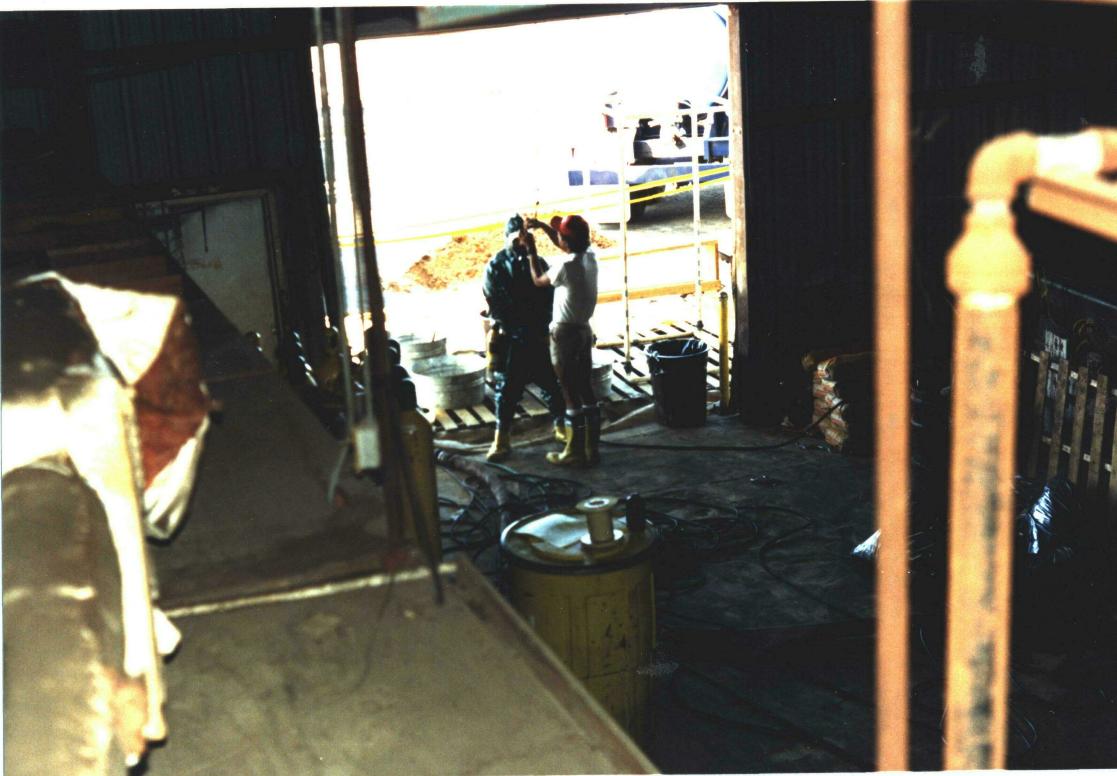
Comments: ERCS crew entering EZ in level
B protection.

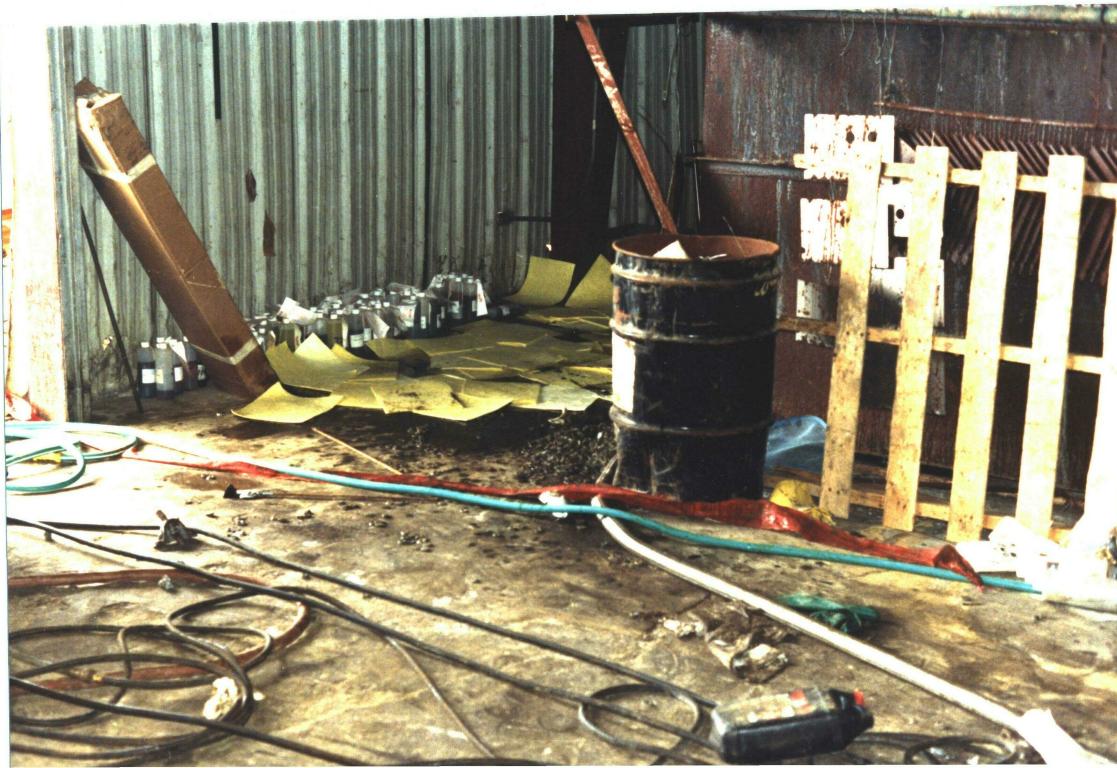
Comments: Sample bottles to be put in vat
wastes for disposal.

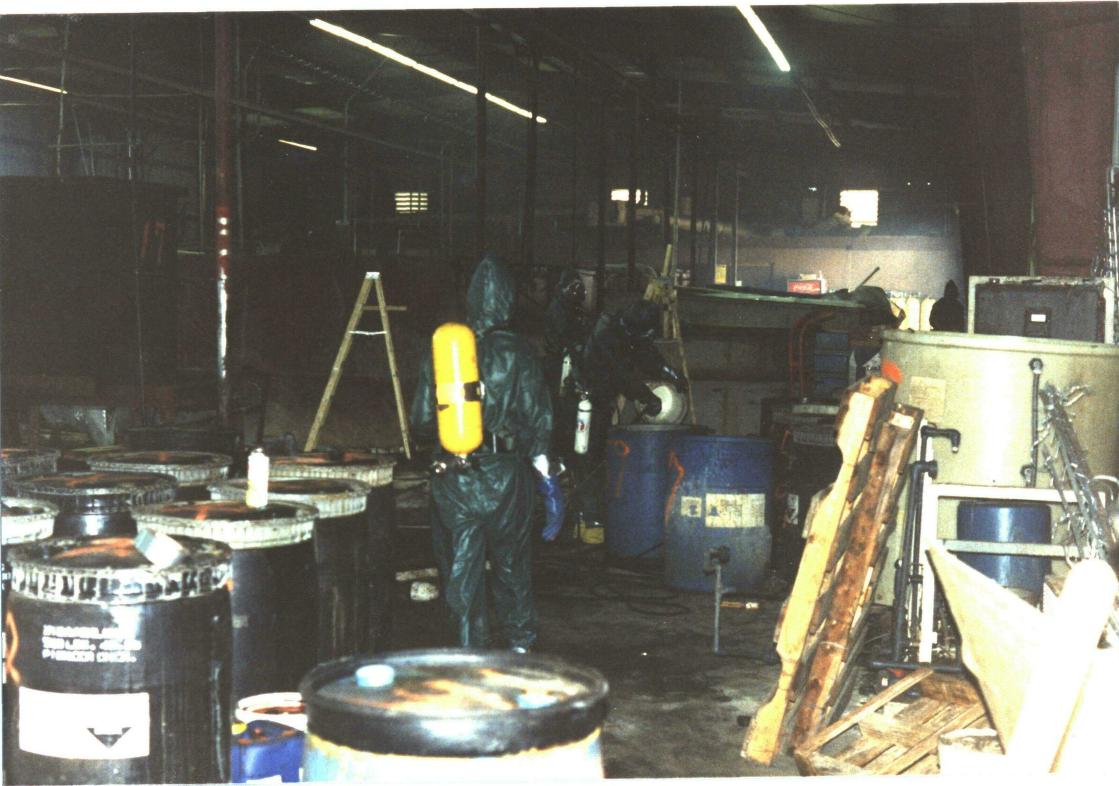
Comments: Crew rinsing drums to collect
rinsate and pump into vats for disposal.

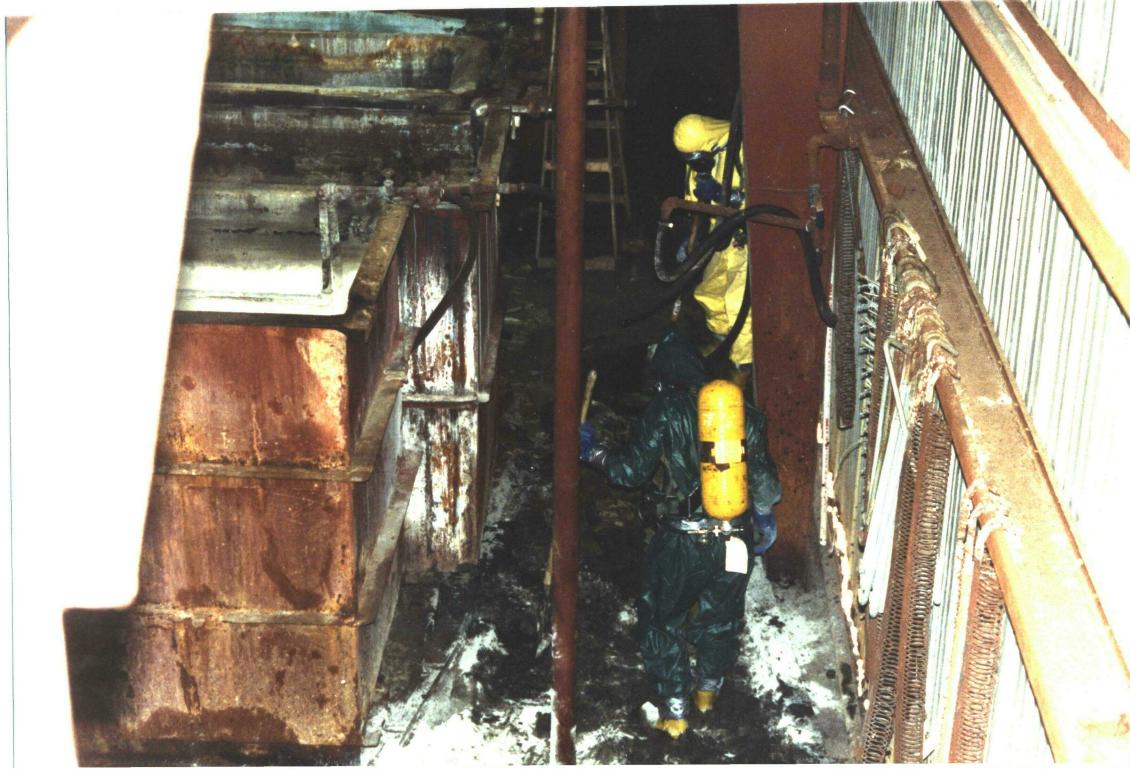
Comments: Crew collecting solidify material
on warehouse floor for incorporation into
site wastes.

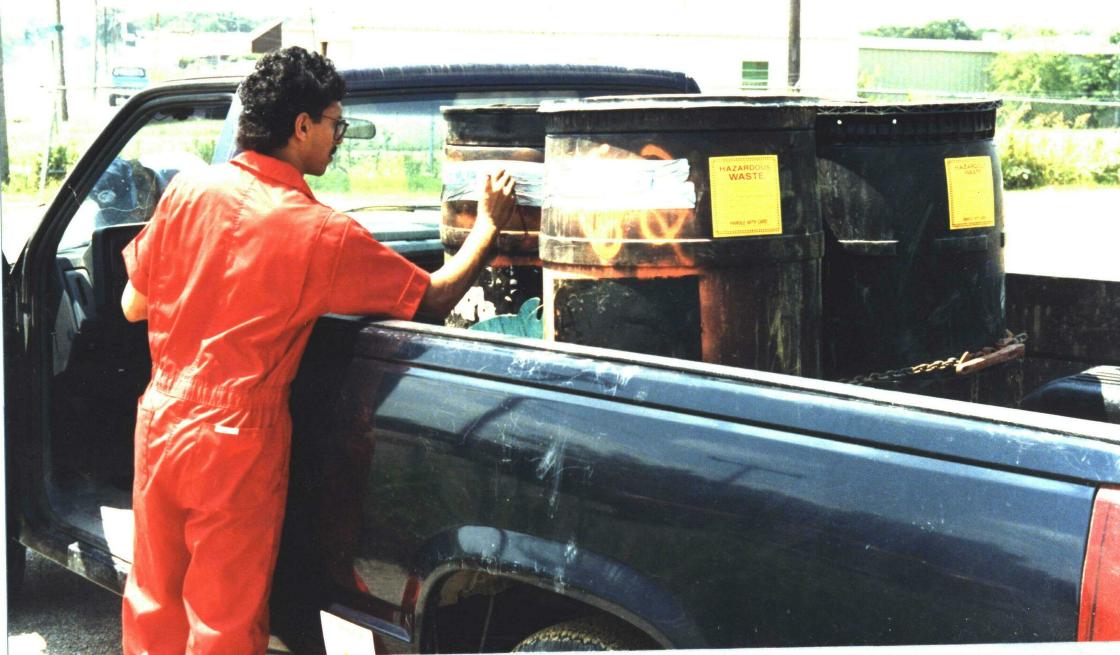
Comments: Pick-up used to transport drums to disposal facility.

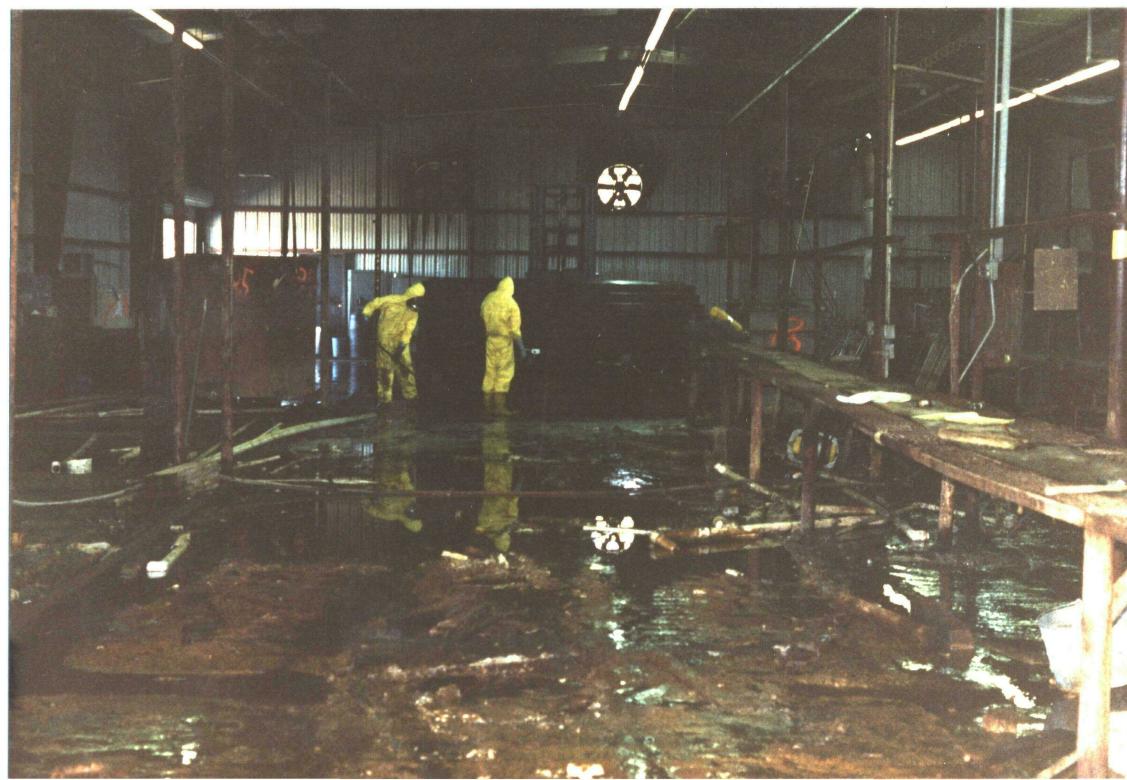
Comments: Crew putting debris into vat to consolidate wastes for offsite disposal.

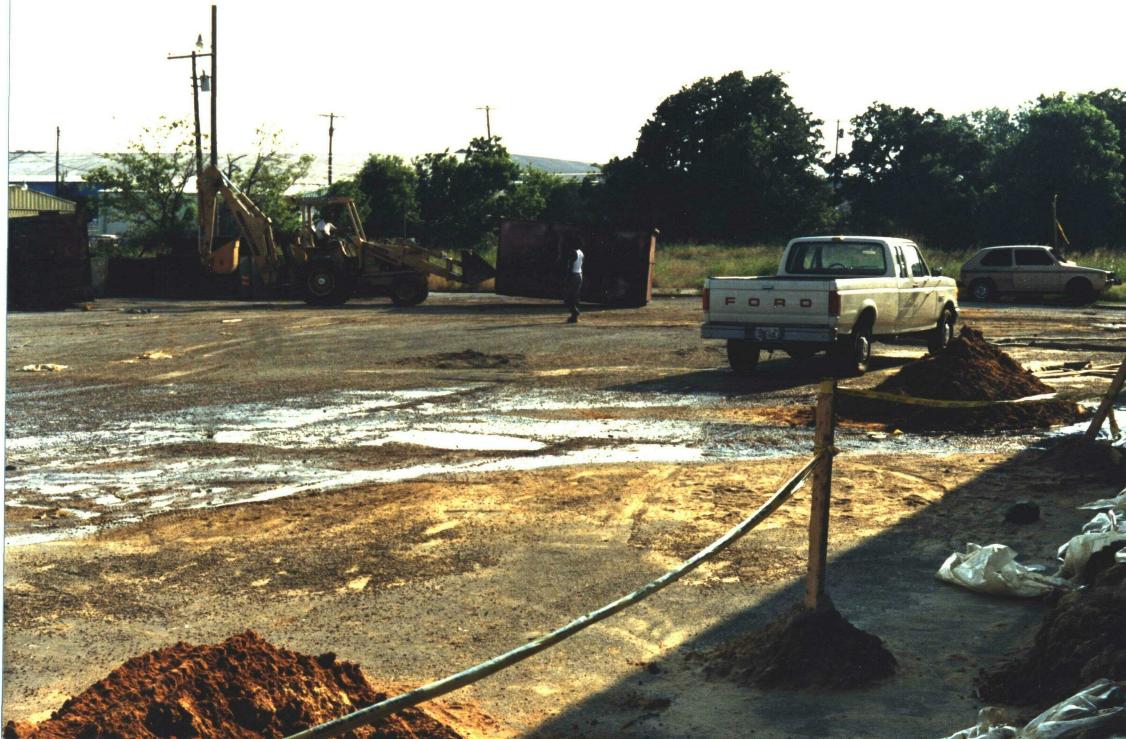
Comments: Crew moving vats to parking lot with backhoe for scrap metal disposal.
